# Design and Testing of Residential Deck Guard Rail Connections

Dr. Joseph R. Loferski,  
Professor  
Dept. Wood Science and Forest Products, Virginia Tech  
Blacksburg, VA USA  
And  
Dr. Frank E. Woeste,  
Professor Emeritus  
Virginia Tech  
Blacksburg, VA USA

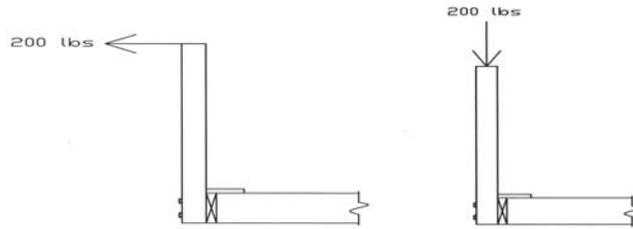
*Figure 1 Vertical and horizontal loads applied to the top of post (890 N=200 lbs)*

The vertical loads produce a shear force in the post-to-deck connection, and this force is relatively easy to resist because bolt or screw connections are very strong in shear. The horizontal loads however, are very difficult to resist because of the lever arm effect. The 890 N load applied at the top of the post produces thousands Newtons at the base of the post that must be resisted by the connection. The famous Greek scientist Archimedes once said “give me a long enough lever and a fulcrum point and I can move the world”. This same concept is the problem we face when trying to design a post-to-deck connection. For the tests described in this paper we applied a horizontal load to the top of the post and measured the maximum force each connection design could resist. We also measured the deflection of the post even though the building code does not specify any requirements for post deflection.

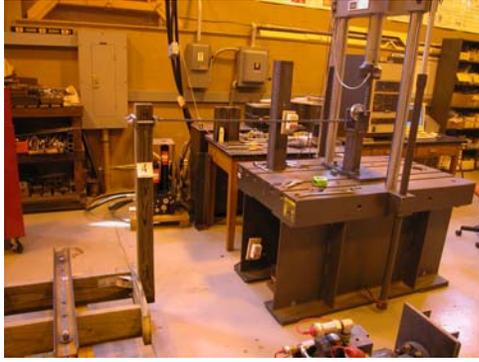
*Figure 2 Test set-up for rail posts showing roller chain and pulley to redirect force from test machine to top of post*

We used the requirements set by the IRC (2000, 2003) to define the basic geometry for our test program. We assumed that the railing was 914 mm above the deck surface as specified by IRC and that the deck boards are 38.1 mm thick. This means that the horizontal load is applied to the post 952.5 mm above the top of the joist. We built a test frame for our Universal testing machine that is shown in Figures 2 and 3. The test set-up has a roller chain attached to the load cell of the machine and a pulley to redirect the force from the vertical motion of the machine to a horizontal force that is applied to the top of the post. The post is attached to a simulated deck system that includes two joists and a band joist with the post attached to the band joist, just as in a real deck. The deck system is firmly attached to the concrete floor of the laboratory so it cannot move during a test. We attached a transducer to the deck system to measure any motion just to verify that the deck was indeed rigidly attached to the floor. We also attached a transducer to the post to measure how much it deflected during a test.

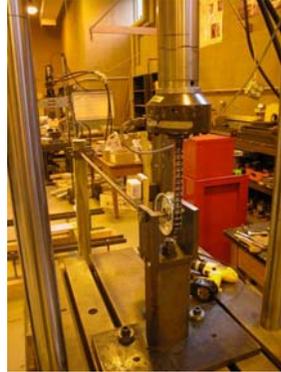
*Figure 3 Test set-up showing close-up of loading*

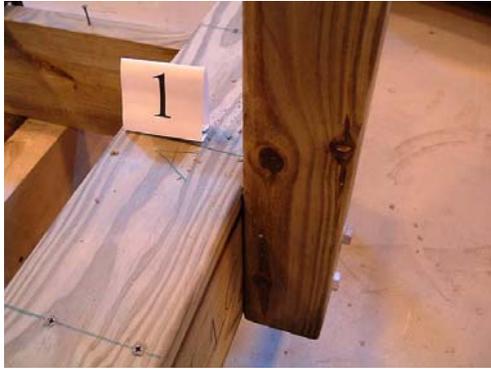
*Figure 4 Specimen with deck board and post*

For joints where the post is bolted to the band joist, the connections failed at an average load of 1 kN—barely surpassing the design load but with virtually no safety factor in the event of an overload. The bolted connections typically failed when the band joist “peeled” away from the deck joists as the screws that attached the band to the joists failed in withdrawal (Figure 5). We tested specimens with deck boards screwed to both the band joist and the deck joists in hope of increasing the failure loads. However, the screws failed early in the test and did not provide increased load resistance. Figures 4 and 5 show a typical failure of a specimen.

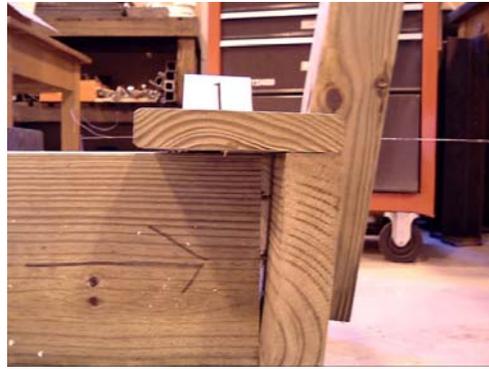
*Figure 5 Failure of screws in withdrawal from joists*

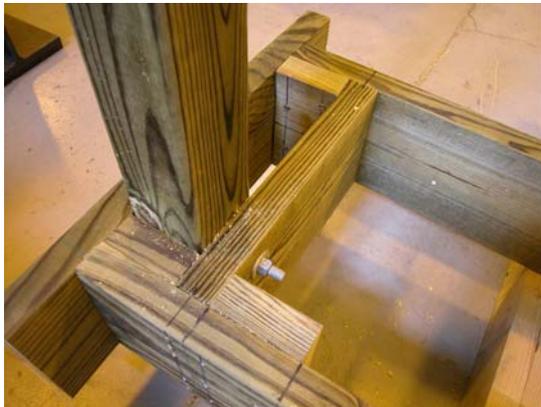
*Figure 6 Wood cleats did not work*

We tested a variety of designs involving wood cleats that were lag screwed to the joists, and had bolts installed through the band, the post and the cleat as shown in Figures 6 and 7. The idea was to distribute the load over many fasteners and hopefully achieve the 2.22 kN load level. However, these designs did not withstand the required load because the wood failed in tension perpendicular to the grain in the cleat as shown in Figure 7.

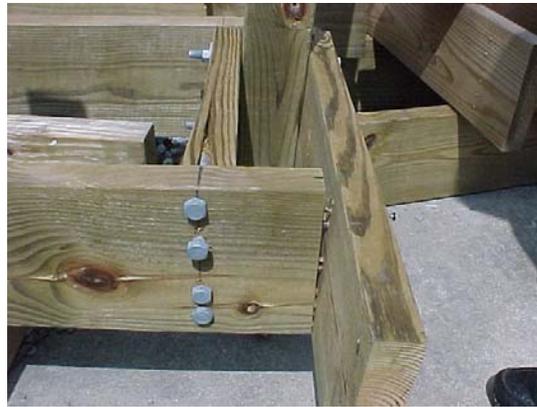
*Figure 7 Splitting perpendicular to the grain in the wood cleats*

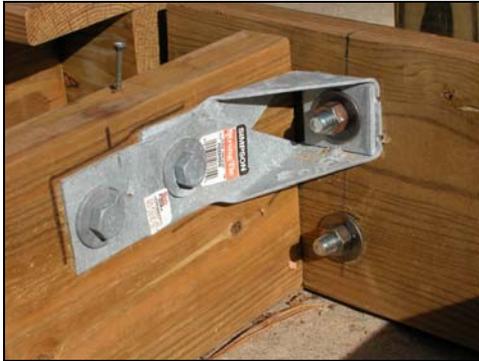
Figure 8 Connector holding post to joist with bolts

We identified commercial steel connector plates that are designed for earthquake resistance in shear walls but could also be used to attach the post to the deck joists as shown in Figures 8 and 9. These connectors use three 12.7 mm (1/2 in.) diameter bolts: two bolts are installed in the joist and are loaded in shear, and the third 12.7 mm (1/2 in.) bolt passes through the post, the band, and the connector itself. This third bolt is loaded in tension. Figure 10 shows front and side views of the connection.

The design uses a fourth bolt through the lower part of the post and the band to prevent rotation of the post. Only one connector is used per post and it is located 50.8 mm (2 in.) below the top edge of the joist to provide proper edge distance for the bolts. We purchased hot dipped galvanized Simpson Strong-Tie HD2A hold-down connectors and installed them as shown in Figures 8 to 10.

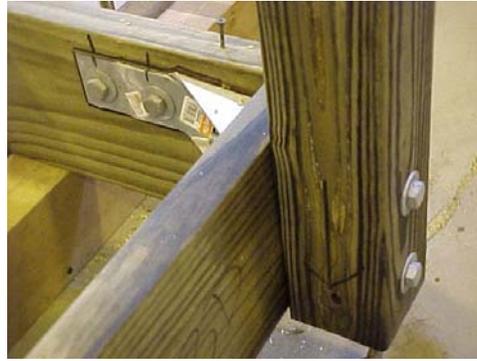
Figure 9 Another view of connection showing post located “outside” the band joist

Using the connectors, we tested two joint configurations with five replications of each as follows: one with the post located inside the band as shown in Figure 10, and the other with the post located outside the band joist as shown in Figures 9, 11 and 12. These configurations provide flexibility in locating the post. We observed different failure modes for the two cases. When mounted inside the band, the washers under the bolt head embedded into the surface of the band joist and produced a stiff joint. When the post is located outside the band, the bolt head and washer pulled into the post and this produced more deflection at the top of the post.

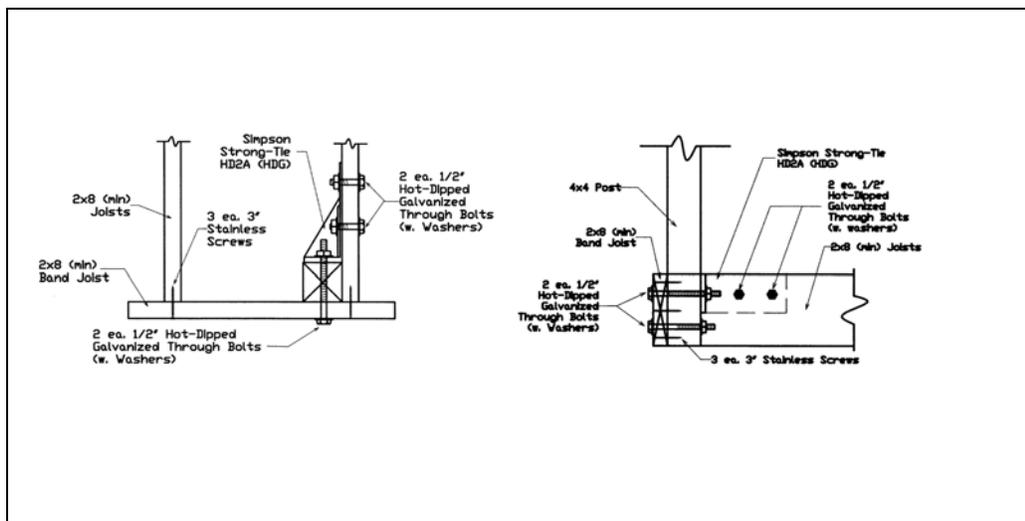
Figure 10 Schematic drawing showing top and side views of the post connection that passed the minimum load requirement

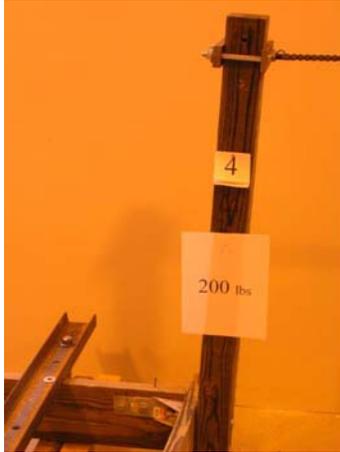
*Figure 11 The post loaded with the design load of 0.889 kN*

Figure 11 shows the post loaded at the design load and the relatively small amount of deflection of the post. Figure 12 shows the same post loaded at the 2.5 times the design load, and even with the large amount of deflection the connection is still capable of carrying additional load.

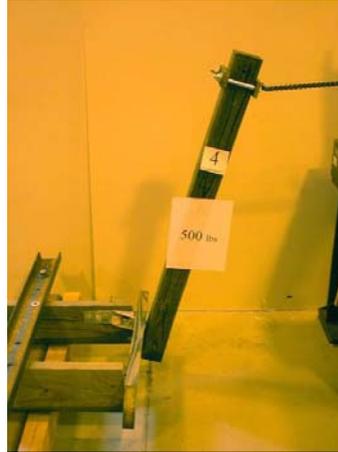
*Figure 12 The post loaded with 2.5 safety factor of 2.22 kN*
